**Flood Control Project Maintenance
Levee Inspections****LMA District Cover Sheet
Spring 2016 Levee Inspection Results****California Department of Fish and Game Shea Levee**

Spring 2016 Levee Inspection Results

California Department of Fish and Game Shea Levee

Waterway			Bank	Unit Miles
Unit No. 01 Sacramento River			Left	0.30
	Spring (March - May)	Summer (June - August)	(September - November) Fall	Winter (December - February)
Unit Maintenance Rating (Fall Only)				
Date of Inspection	4/27/2016 - 4/27/2016			
DWR Inspector	Keith Millard			
Accompanied By	Michael Harris Department of Fish and Game

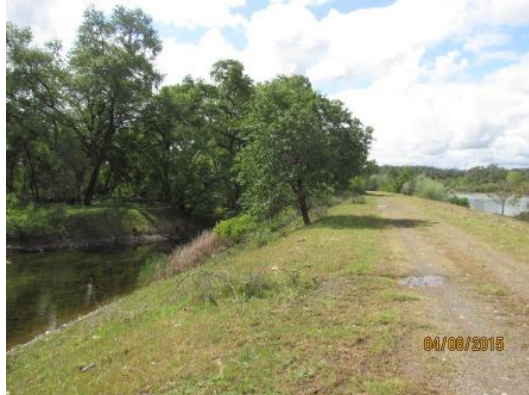
Photo 1 of 2 : SP_2016_NA0018_269_2_20160316_00003.jpg

LM Start	0.00	Rating **	M	Issue No.	2
LM End	0.07	Issue Type +	Ma	Location *	LS
Category	Earthen Levee			GPS Latitude/Longitude	
				Start	End
Item	Vegetation			40.508138 °	40.508138 °
				-122.363480 °	-122.363480 °
DWR ID	DWR_NA0018_01_s_2012_2				
Comment Code					
V2 : Remove the wild growth other than native grasses from the levee slopes.					
Inspector Comment					
California Department of Fish and Wildlife has not completed any maintenance this year.

View of the levee with no maintenance done.

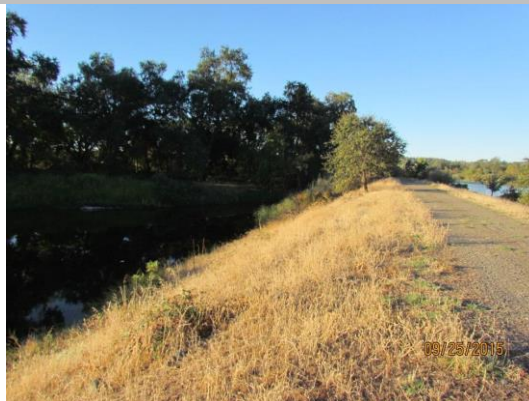
Photo 2 of 2 : SP_2016_NA0018_269_2_20160316_00004.jpg

View of the levee with no maintenance done.

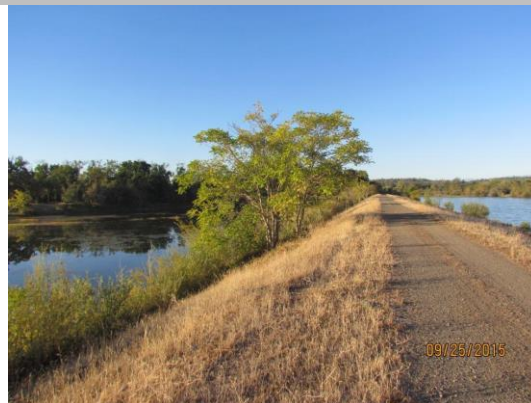
Photo 2 of 2 : SP_2016_NA0018_269_9_20160316_00010.jpg

LM Start	0.00	Rating **	M	Issue No.	9 (cont)	
LM End	0.21	Issue Type +	Ma	Location *	LS	
Category	Earthen Levee			GPS Latitude/Longitude		
				Start		End
Item	Trim / Thin Trees			40.509012 °		40.510649 °
				-122.362609 °		-122.360945 °
DWR ID	DWR_NA0018_01_f_2012_9					
Comment Code						
T2 : Thin trees to allow visibility of the ground and room to flood fight.						
Inspector Comment						
Fish and Wildlife Service has not completed any maintenance.

Remove the small trees along the landside slope.

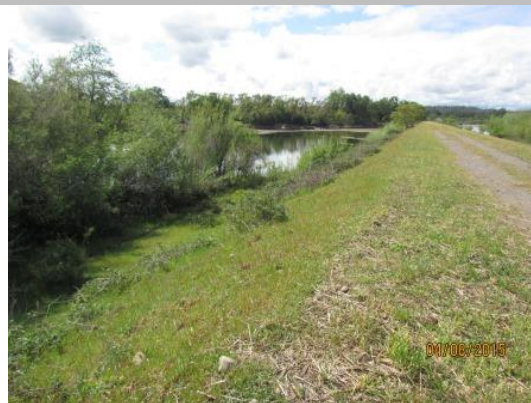
Photo 1 of 3 : SP_2016_NA0018_269_1_20160316_00001.jpg

LM Start	0.10	Rating **	M	Issue No.	1
LM End	0.30	Issue Type +	Ma	Location *	LS
Category	Earthen Levee			GPS Latitude/Longitude	
				Start	End
Item	Vegetation			40.511185 °	40.510670 °
				-122.360553 °	-122.361203 °
DWR ID	DWR_NA0018_01_s_2012_1				
Comment Code					
V2 : Remove the wild growth other than native grasses from the levee slopes.					
Inspector Comment					
Fish and Wildlife Service has not completed any maintenance.

View of the blackberries and other vegetation along the landside slope.

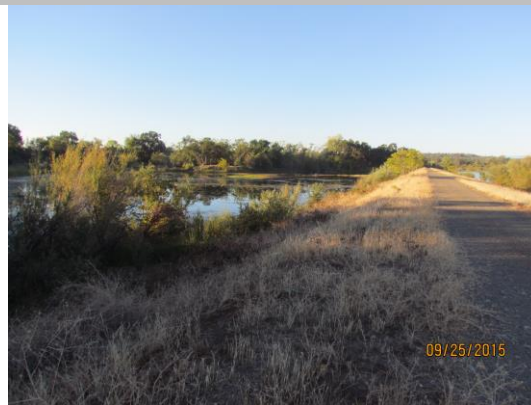
Photo 2 of 3 : SP_2016_NA0018_269_1_20160316_00002.jpg

View of the blackberries and other vegetation along the landside slope.

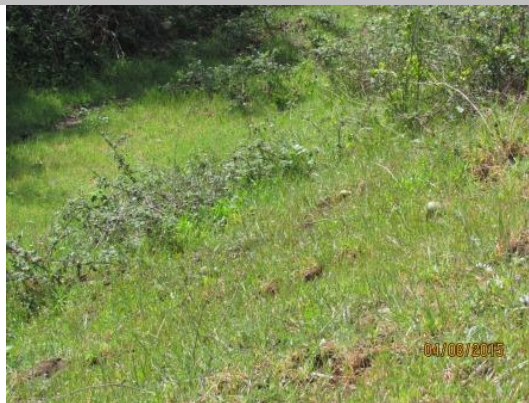
Photo 1 of 2 : SP_2016_NA0018_269_6_20160316_00007.jpg

LM Start	0.22	Rating **	M	Issue No.	6
LM End	0.30	Issue Type +	Ma	Location *	LS
Category	Earthen Levee			GPS Latitude/Longitude	
				Start	End
Item	Animal Control			40.510671 °	40.511185 °
				122.360944 °	122.360553 °
DWR ID	DWR_NA0018_01_s _ 2013_6				
Comment Code					
A2 : Repair the levee slope damaged by livestock and prevent large animal access.					
Inspector Comment					
The livestock damaged the L/S slope.

View of the livestock erosion along the landside slope.

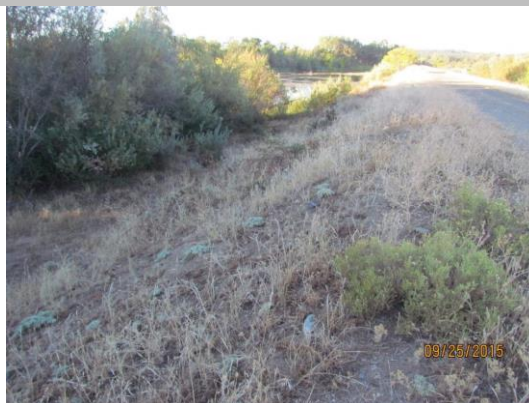
Photo 2 of 2 : SP_2016_NA0018_269_6_20160316_00008.jpg

View of the livestock erosion along the landside slope.
